MOV Diagnostics Program

AOV and MOV preventive maintenance programs to increase overall health, performance and reliability.

Examples of Diagnostic Findings

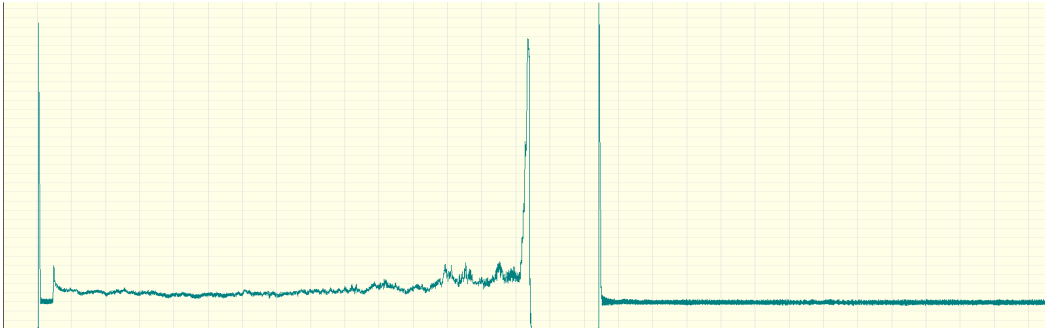
Degraded Actuator Bearing

The graph above represents motor power trace. You can see as the valve is closing, the graph has multiple spikes throughout the stroke. The open side is smooth (as expected). This is an indication of upper drive sleeve bearing wear or damage.
